Manhole Inspection Summary

Manhole # S23KK_056MH

Insp Date: **9/28/07 9:55 AM**

Location Address: **2453 WOODBROOK AVE**

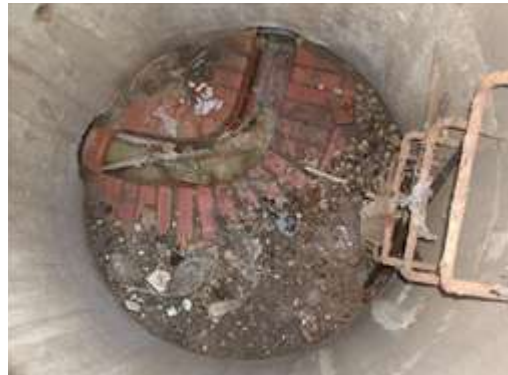
Top View

Corroded steps. Evidence of surcharge - Bench debris. Channel debris.

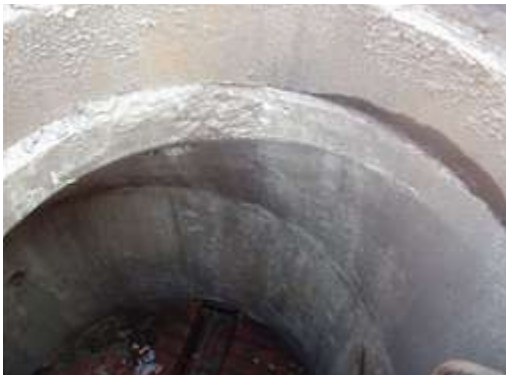
Defect

Frame leaks. Adjustment infiltration - other side.

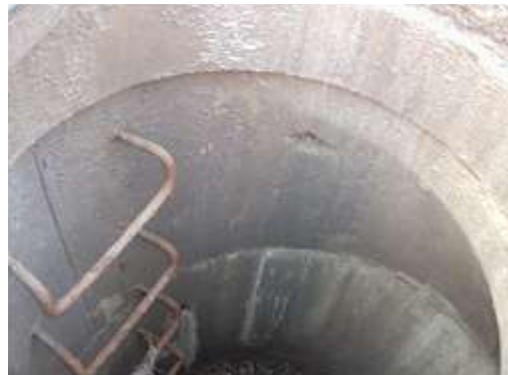
Defect

Frame leaks. Adjustment infiltration.

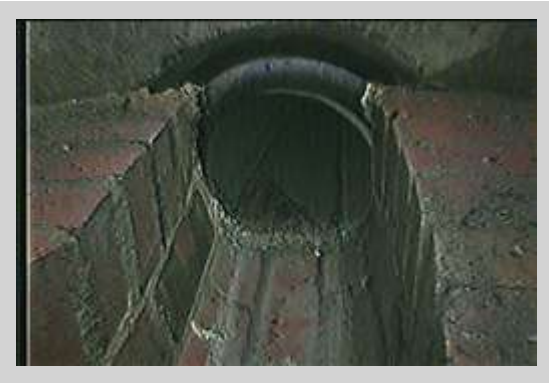
8 in. Circular Gravity Sewer Pipe Out @ 12 O'Clock

Invert Depth: **8.80** (ft.) Flow Characteristics: **Slow**

Deposits: ☒ None ☐ **Mud** ☐ Sludge ☐ **Debris** ☐ **Grease**

Infiltration: **Evidence** Pipe Seal Cond: **Unknown**

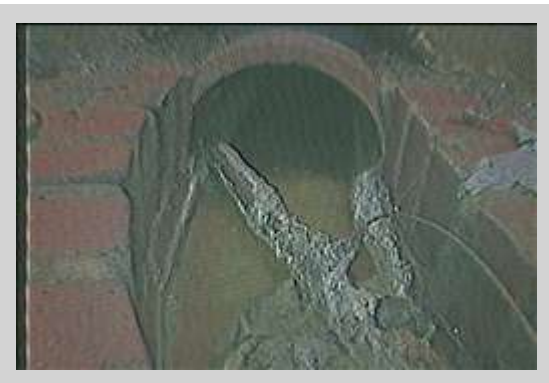
8 in. Circular Gravity Sewer Pipe In @ 9 O'Clock

Invert Depth: **8.70** (ft.) Flow Characteristics: **Slow**

Deposits: ☐ None ☒ **Mud** ☐ Sludge ☒ **Debris** ☒ **Grease**

Silt Depth: **0** (in.) Deposits Extent: **Light**
